# APP1-Built Heritage Inventory of Heritage Sites In SCHED1-HH

## SCHED1- HH – Historic Heritage

## HH-01: Arapuni Suspension Bridge

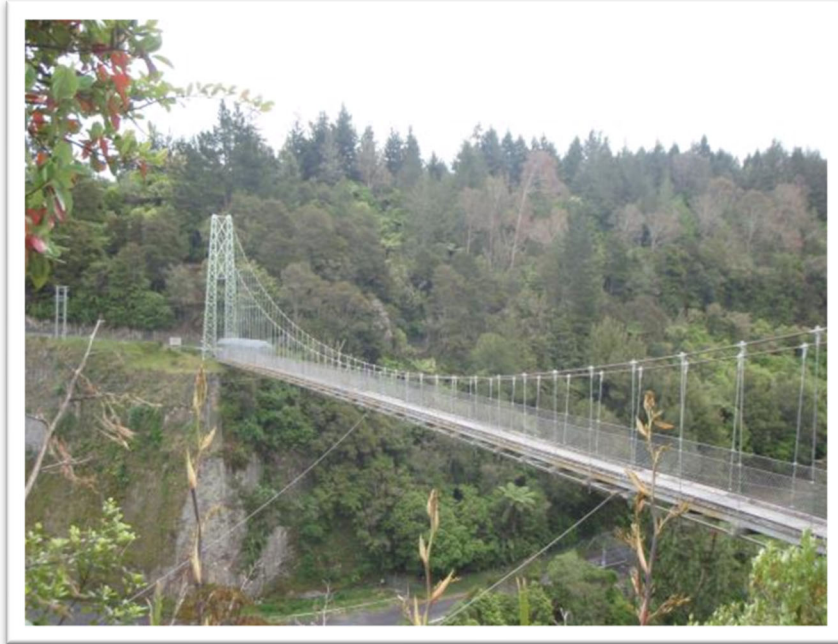
Date of Construction	1925-1926
Materials	Concrete anchors and foundation; One concrete tower and one steel; steel cables; suspender rods and angles; timber joists & wooden decking. (HNZPT) 480-500 ft long. 320ft east end, 274ft west end above sea level.
Architecture/Engineer/Builder	Architect: Armstrong, Whitworth & Co Ltd (Newcastle) Builder: David Rowell & Co. Ltd of Westminster, UK. (HNZPT)
Condition	Good condition and high level of integrity. (HNZPT). Signs on the bridge limit the number of people crossing at any one time. Mercury Energy undertakes regular condition assessments, and reserves the right to close off the bridge for safety or maintenance reasons. (Mighty River Power, Feb 2001).

Pedestrian bridge for use in association with dam construction. The suspension bridge has a span of 152m across the Arapuni Gorge one mile from the dam. Deck 1.2m wide and descends at a grade of 1 in 10 from the eastern bank of the river. The deck is approximately 50m above the water. It is an important ancillary structure to what was New Zealand's largest civil engineering undertaking at the time. Structure likely to have been shipped prefabricated from England and erected by British Contractors, Armstrong Whitford. It connected "Top Camp", eventually to become the permanent township of Arapuni, with the western side of the gorge. Top Camp accommodated workers employed on the construction of the spillway, power station, penstock and outdoor station. The bridge still provides essential access between Arapuni and the Hydro Electric installation. (HNZPT). In 1926, a pipe suspension bridge was constructed to convey water to the construction site, for access to the site by workers. The bridge still carries a water pipe that conveys potable water to the outdoor switchyard. The bridge also carries communications cables. (Mighty River Power, Feb 2001).

Repair of the Structure – PER. Refer to HH-R1. Protection focus - 6, 9, 11 and 13. Building Materials Rule: If repair of the structure is proposed theatricals used for the exterior walls and elements should be similar in type, dimensions and profile as the existing fabric of the *building*. Design Rule: Repair or replication work should match the existing design and profile of the element.

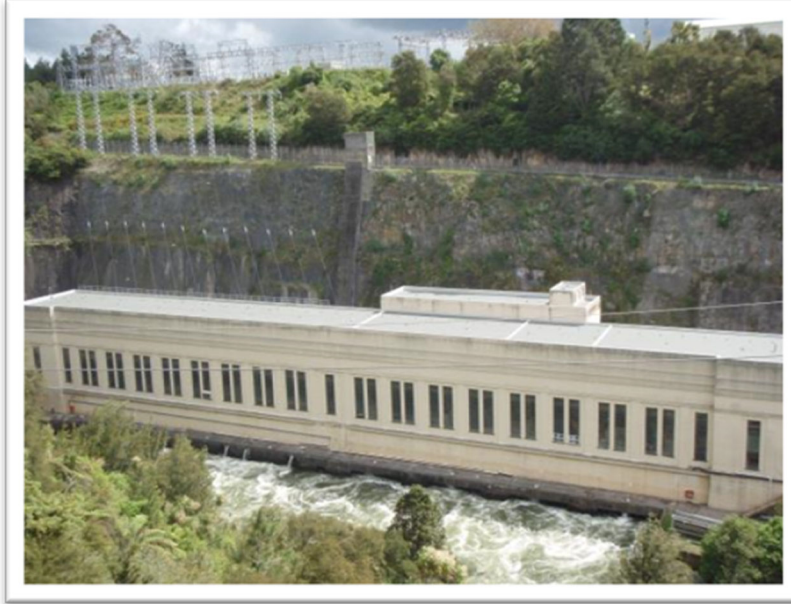
## HH-02: Arapuni Power House

Date of Construction	1924 - Completed 1929
Materials	Steel frame reinforced concrete walls. Galvanised steel frame windows glazed with glass at least 21lbs per sq ft. Roof flat concrete slab to 100lb per sq. ft. Generator floor mass concrete, others reinforced concrete. (HNZPT).
Architecture/Engineer/Builder	F.W. Furkett, Engineer-In-Chief. Frederick Templeton Manheim Kissel - Engineer. Builder: Sir William G. Armstrong, Whitworth and Co. Ltd of Newcastle-On-Tyne 1924-Dec 1927. NZ Public Works Department Dec 1927-1929, (HNZPT)
Condition	Good condition and high level of integrity. (HNZPT). Extensions (new superintendent's office of reinforced concrete and roof waterproof) commenced Aug 1934, completed 1938. Further units commissioned 1945.

First state built hydro dam on Waikato River. For many years New Zealand's largest dam at 157,000KW. Length 136.33m width 22.87m, tailrace water level to roof 21.96m. The Arapuni complex (Dam, Powerhouse & associated works) was of an unprecedented magnitude in New Zealand engineering. Public doubts were raised about the Public Works Department ability to undertake the project. In the end the Department's layout and design were adopted but overseas contractors, Armstrong, Whitford & Co Ltd, carried out construction. Powerhouse was constructed in two parts - the north end of the *building* between 1924 and 1929, and the south end was added between 1934 and 1946. (Mighty River Power Feb 2001). The first electricity from Arapuni was delivered on 4 June 1929. Power generation was stopped in 1930 when damage to the station was sustained as a result of significant rock movement. Remedial works were carried out by the Public Works Department and the generation of electricity resumed in April 1932.(HNZPT).

Repair of the Structure - PER. Refer to HH-R1. Protection focus - 6, 9, 11 and 13. Building Materials Rule: If repair of the *buildings* is proposed the materials used for the exterior walls should be similar in type, dimensions and profile as the existing exterior fabric of the *building*. Design Rule: Repair or replication work should match the existing design and profile of element.

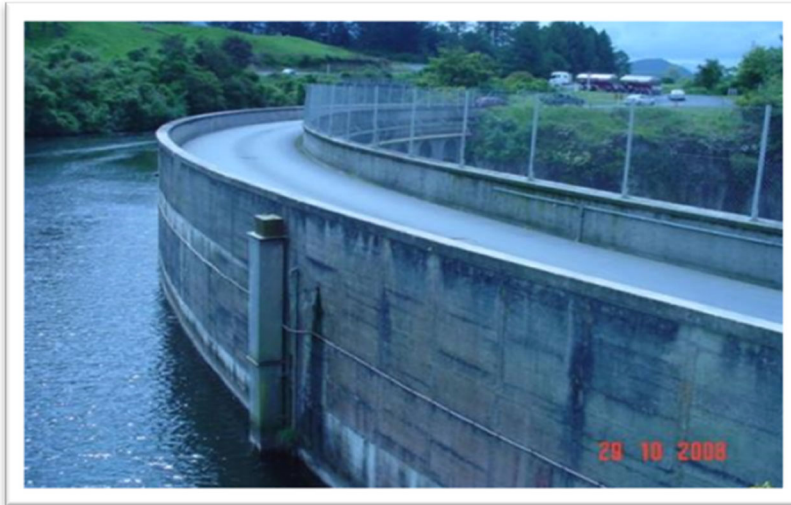
## HH-03: Arapuni Dam

Date of Construction	1924 - 1929
Materials	Curved gravity dam; reinforced concrete, foundations excavated 9.1m below the river bed.
Architecture/Engineer/Builder	F.W. Furekett, Engineer-In-Chief. Engineer: Frederick Templeton Manheim Kissel (1881-1962). Builder: Sir William G. Armstrong, Whitworth and Co. Ltd of Newcastle-On-Tyne 1924-Dec 1927. NZ Public Works Department Dec 1927-1929.
Condition	Good condition and high level of integrity. (HNZPT). Height from bottom of foundations to roadway 64.05m. Maximum thickness at base 52.15m. Length at crest 93.64m. Total concrete in dam 155,000 tons. Erection of 2.0m fence to existing balustrade on the downstream side of dam in 2001. (HNZPT). A locked fence limits access to base of the dam. Dam safety is reviewed every 5 years as part of Mighty River Power's dam safety management programme. Mighty River Power monitors groundwater levels, pressures and drainage flows in and around the

dam. The company follows the guidelines of the NZ Society of Large Dams. A gas pipeline runs along the downstream face of the dam. (Mighty River Power, Feb 2001).
Original Site Recommendation	HNZPT Ref: 4154. Heritage Advisor, HNZPT. Additional information can be found in "The History of Arapuni" I.J. Southward.
Current Use	Hydro-electricity generation

Repair of the Structure - PER. Refer to HH-R1. Protection focus - 9, 11 and 13. Building Materials Rule: If repair of the *buildings* is proposed the materials used for the exterior walls should be similar in type, dimensions and profile as the existing exterior fabric of the *building*. Design Rule: Repair and replication work should match the existing design and profile of the element.

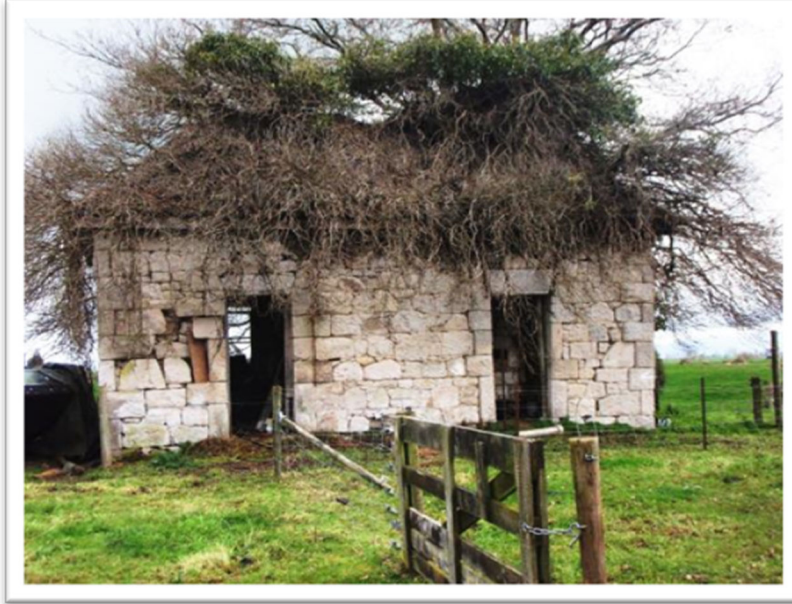
## HH-04: Bake House – Dairy

Date of Construction	circa 1884
Materials	Rectangular structure with hipped roof. Walls made of local Volcanic Tuff (Hinuera Stone); roof is corrugated iron. (NZHPT).
Architecture/Engineer/Builder	Unknown
Condition	In very poor condition. Stonework damage. Roof requires repairing. <i>Building</i> overgrown with rampant climbing plant. (HNZPT).
Original Site Recommendation	HNZPT Ref: 4237. Heritage Advisor, HNZPT and A. Simmons.
Current Use	Farm storage shed

Repair of the Structure - PER. Refer to HH-R1 Protection focus - 10 and stone. If repair of the *buildings* is proposed the materials used for the exterior walls should be similar in type, dimensions and profile as the existing exterior fabric of the *building*.

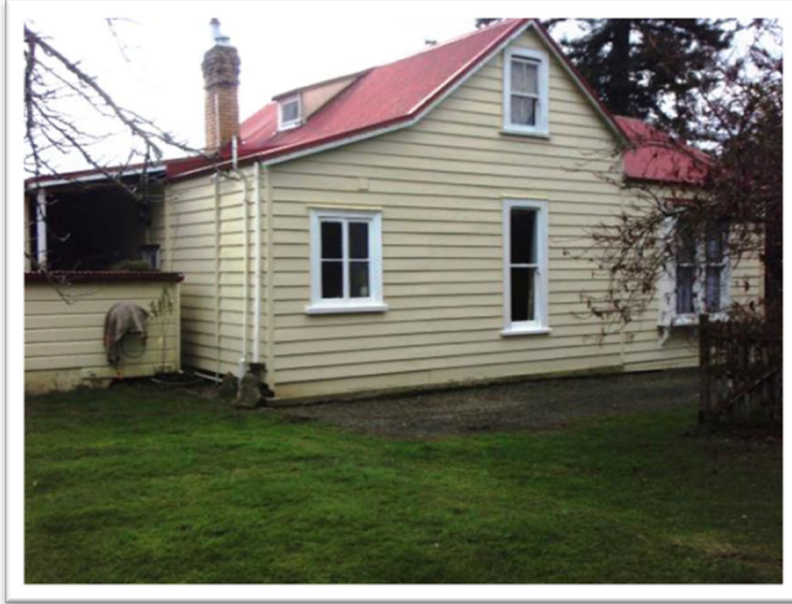
## HH-05: Skimming Factory

Date of Construction	1910
Materials	Heart totara weatherboard with iron roof in original portion of house.
Architecture/Engineer/Builder	Unknown
Condition	Generally good. New roof 2001. Owners undertaking repairs and restoration. Converted to residence by Lowe family in 1923. Some additions (including bedroom near veranda) made however date unknown. (HNZPT).
Original Site Recommendation	HNZPT Ref: 4236. Heritage Advisor, HNZPT.

Repair of the Structure - PER. Refer to HH-R1. Protection focus - 11. If repair to the structure is proposed the materials used for the exterior walls should be similar in type, dimensions and profile as the existing exterior fabric of the building.

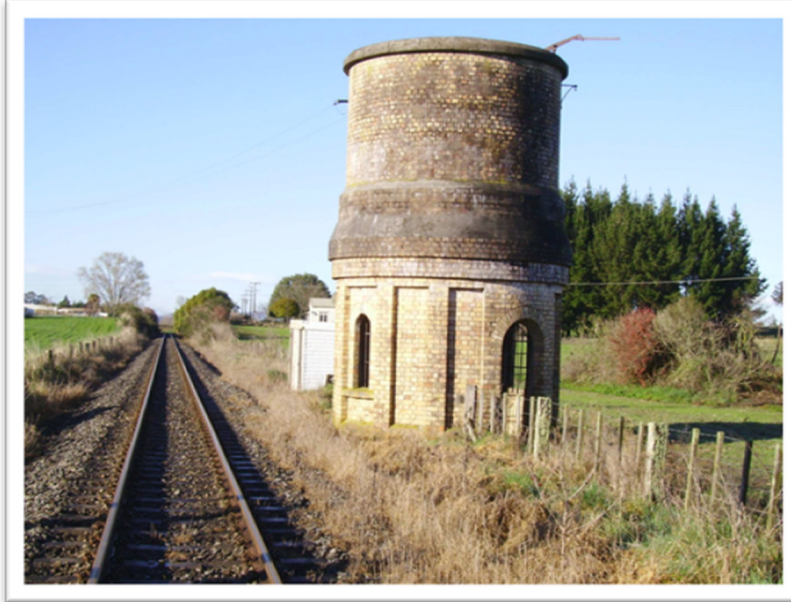
## HH-06: Lichfield Water Tower

Date of Construction	1885 - 1886
Materials	Two storied brick cylinder.
Architecture/Engineer/Builder	Engineer: James Stewart CE., Builder: Daniell Fullon (HNZPT).
Condition	Is in good condition. Water supply disconnected. The design of brick work is different to two other water towers in District; Ngatira and Tirau. The tower is essential infrastructure to the private railway. Tower is of robust construction in comparison to towers associated with public railway. (HNZPT).
Original Site Recommendation	HNZPT Ref: 4235. Heritage Advisor, HNZPT
Current Use	Railway water tower - disused

Repair of the Structure - PER. Refer to HH-R1. Protection focus - 1, 6, 10, 12 and 13. Building Materials Rule: If repair of the *buildings* is proposed the materials used for the exterior walls and elements should be similar in type, dimensions and profile as the existing exterior fabric of building. Design Rule: Repair or replication work should match the existing design and profile of element.

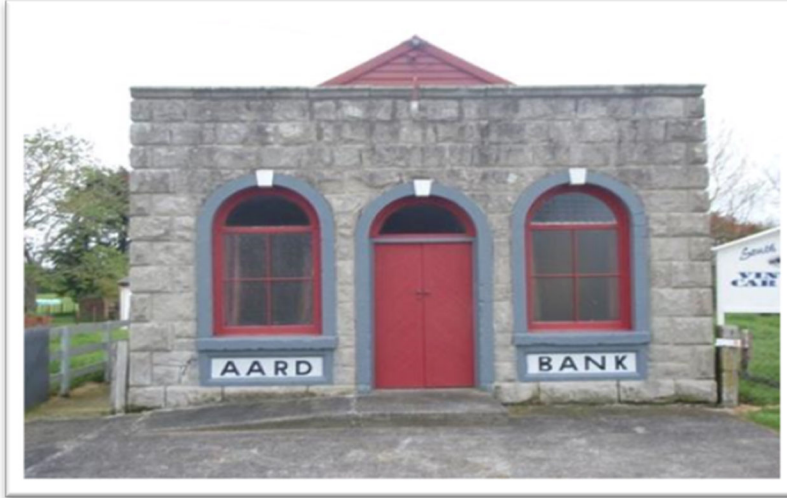
## HH-07: Vintage Car Club Building

Date of Construction	1885 - 1888
Materials	Local rock walls with corrugated iron roof. More recent lean-to attachment at rear in timber. Lichfield Stone - Putaruru Ignimbrite (quarried from outcrop on nearby Rea's farm)(HNZPT).
Architecture/Engineer/Builder	Unknown
Condition	Excellent condition. Date of wooden additions not known. Renovated after 1995, kitchen added and roof replaced (HNZPT).
Original Site Recommendation	HNZPT Ref: 2689. Heritage Advisor, HNZPT
Current Use	Vintage Car Club recreation room

Repair of the Structure - PER. Refer to HH-R1. Protection focus - 3, 6, 10, 13 and stone. Discretionary - stone. Building Materials Rule: If repair of the buildings is proposed the materials used for the exterior walls and elements should be similar in type, dimensions and profile as the existing exterior fabric of the building. Design Rule: Repair and replication work should match the existing design and profile of element. The window and door surround frames should be retained and be repaired with the materials that match the existing fabric. The windows should be repaired or replicated to retain the historic four-light configuration. The words under the window "AARD" and "BANK" should be retained.

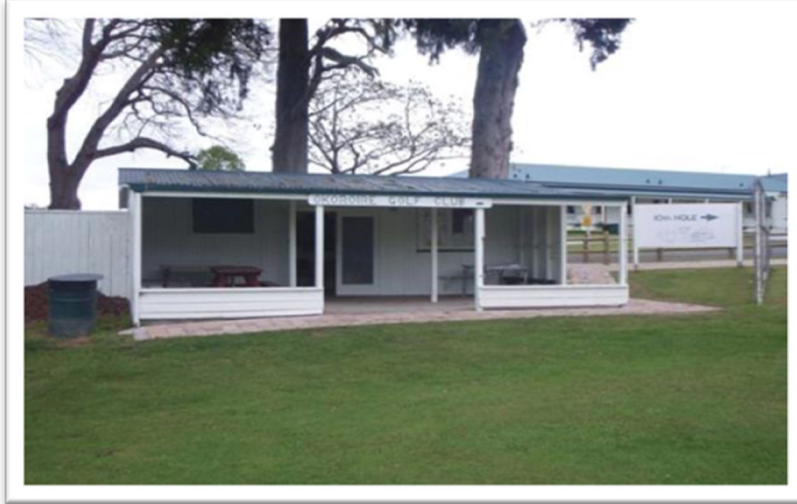
## HH-08: Okoroire Hot Springs Golf Club Pavilion

Date of Construction	1912 - 1913
Materials	Corrugated iron.
Architecture/Engineer/Builder	Unknown
Condition	Good
Original Site Recommendation	HNZPT Ref: 4351. Heritage Advisor, HNZPT.
Current Use	Recreational - Golf Club pavilion

Repair of the Structure - PER. Refer to HH-R1 Protection focus - 3 and 11. Building Materials Rule: If repair of the buildings is proposed the materials used for the exterior walls should be similar in type, dimensions and profile as the existing exterior fabric of the building. Design Rule: repair or replication work should match the existing design and profile of element.

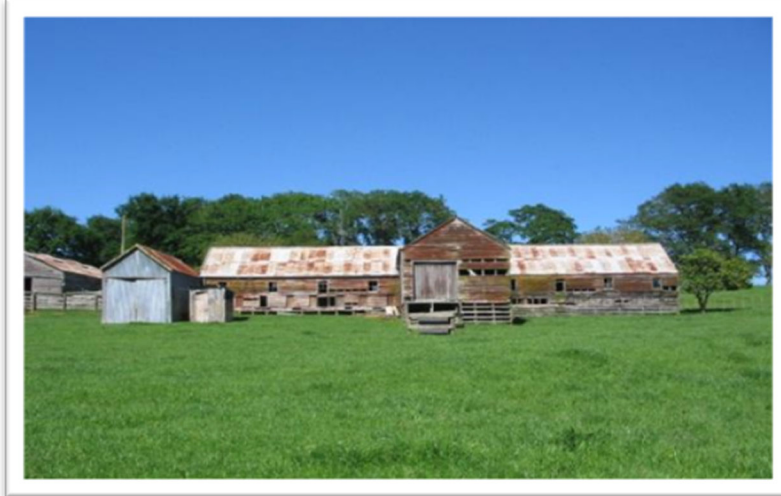
## HH-09: Main Estate Woolshed

Date of Construction	1881 - 1882
Materials	Weatherboard with corrugated iron roofs.
Architecture/Engineer/Builder	Unknown
Condition	Poor condition. Lean-to removed. HNZPT
Original Site Recommendation	HNZPT Ref: 4231. Heritage Advisor, HNZPT.
Current Use	Farm sheds

Repair of the Structure - PER. Refer to HH-R1 Protection focus - 11 and 13. Building Materials Rule: If repair of the buildings is proposed the materials used for the exterior walls should be similar in type, dimensions and profile as the existing exterior fabric of the building. Design Rule: Repair or replication work should match the existing design and profile of element.

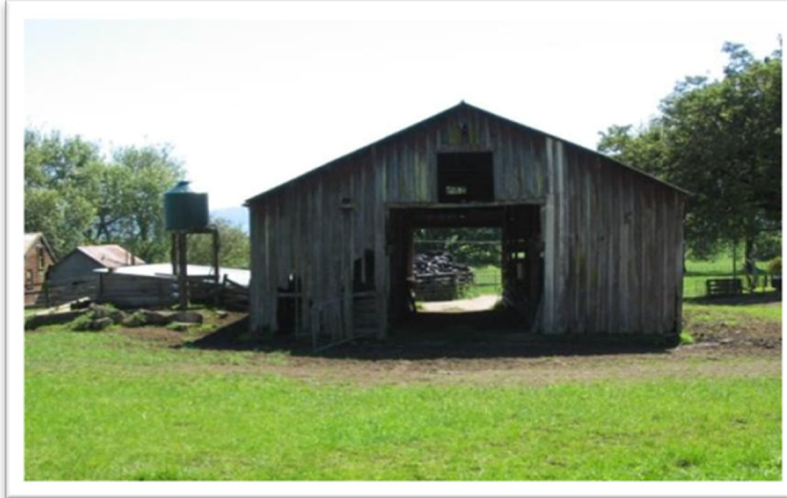
## HH-10: Main Estate Stables

Date of Construction	1881 - 1882
Materials	Weatherboard with corrugated iron roofs.
Architecture/Engineer/Builder	Unknown
Condition	Poor condition. (HNZPT).
Original Site Recommendation	HNZPT Ref: 4232. Heritage Advisor, HNZPT.
Current Use	Farm sheds

Repair of the Structure - PER. Refer to HH-R1. Protection focus - 11 and 13. Building Materials Rule: If repair of the buildings is proposed the materials used for the exterior walls should be similar in type, dimensions and profile as the existing exterior fabric of the building. Design Rule: Repair or replication work should match the existing design and profile of element.

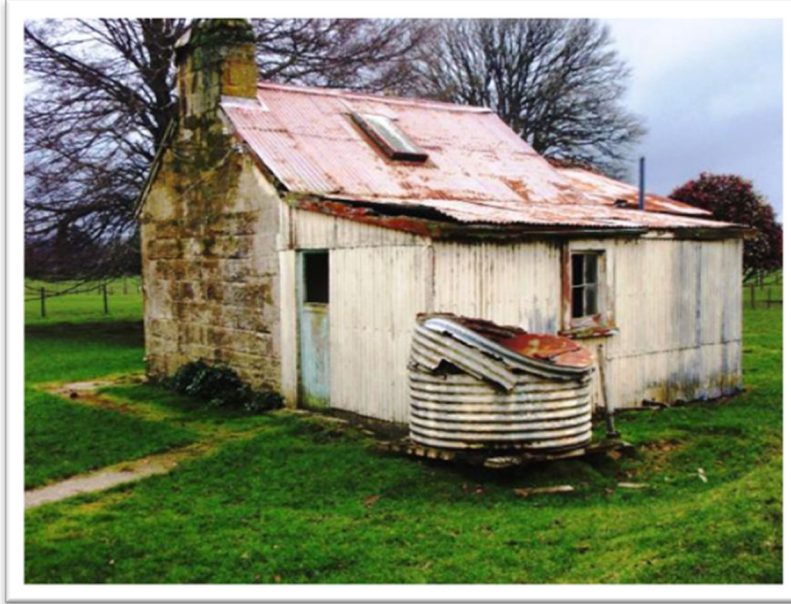
## HH-11: Stone Kitchen

Date of Construction	1880s
Materials	Karapiro Stone. Rare example. Stone is very young compared to Hinuera Stone. HNZPT. Quarried on site. Original windows present. A number of additional sheds (currently used for farm machinery storage) attached to stone kitchen.
Architecture/Engineer/Builder	Unknown
Condition	Poor
Original Site Recommendation	HNZPT Ref: 4229. Heritage Advisor, HNZPT.
Current Use	Redundant farm machinery storage shed.

Repair of the Structure - PER. Refer to HH-R1 Protection focus - 10, 13 and stone. Stone - DIS.  
Building Materials Rule: If repair of the building is proposed the materials used for the exterior walls should be similar in type, dimensions and profile as the existing exterior fabric of the building. Design Rule: Repair or replication work should match the existing design and profile of element.

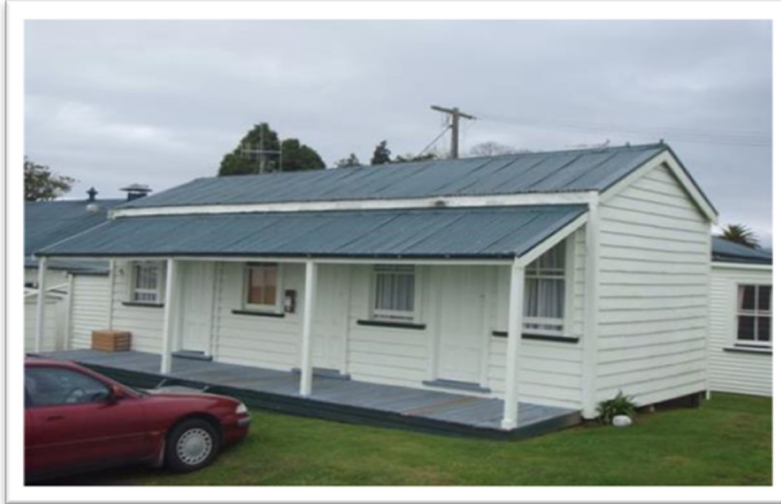
## HH-21: Okoroire Hot Springs Hotel – Staff Accommodation

Okoroire Hot Springs Hotel – Staff accommodation  
Date of Photograph: 16/10/2008

Date of Construction	1884
Materials	Timber and corrugated iron.
Architecture/Engineer/Builder	Unknown
Condition	Good. Repairs undertaken to staff accommodation.
Original Site Recommendation	HNZPT Ref: 4233. Heritage Advisor, HNZPT.
Current Use	Accommodation and storage.

Repair of the Structure - PER. Refer to HH-R1. Protection focus - 3 and 11. Building Materials Rule: If repair of the buildings is proposed the materials used for the exterior walls should be similar in type, dimensions and profile as the existing exterior fabric of the building. Design Rule: Repair and replication work should match the existing design and profile of element.

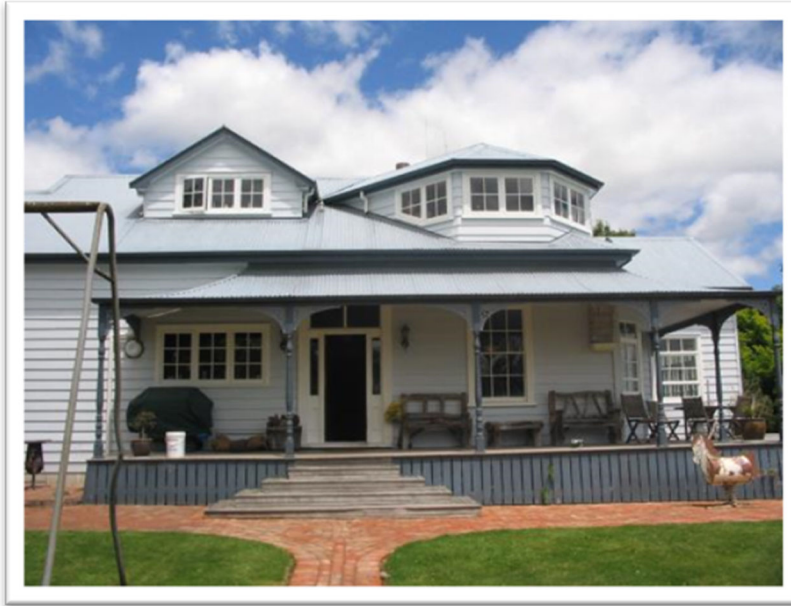
## HH-22: House (Formerly Raparahi Hotel)

Date of Construction	1882 - 1883
Materials	Totara framing, sawn weatherboards, chimney of sawn rhyolite, corrugated iron roof, shingles underneath on earlier part. (HNZPT)
Architecture/Engineer/Builder	Unknown
Condition	Interior reorganised around 1930, reconditioned 1963 and now farmhouse. Fully fenced. Excellent condition. More research required regarding what remains as original and what has undergone alteration
Original Site Recommendation	HNZPT Ref: 4239. Heritage Advisor, HNZPT.
Current Use	Private residence.

Repair of the Structure - PER. Refer to HH-R1. Protection focus - 1.

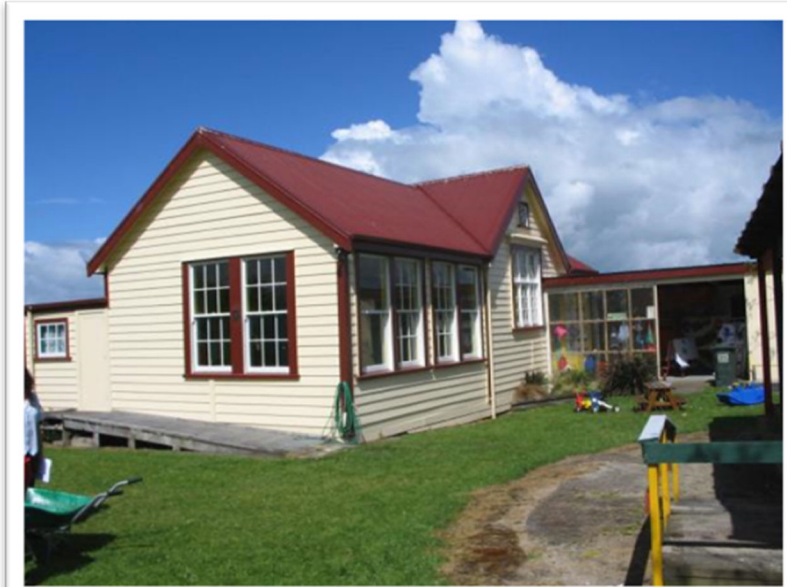
## HH-23: Waotu-Puketurua Play Centre Building

Date of Construction	1886
Materials	Timber & iron roof.
Architecture/Engineer/Builder	Unknown
Condition	Excellent. Building was added to in 1916 and moved in the 1980's. (HNZPT). Fully fenced (Public consultation). Extension undertaken in 2002 enabling more space for play centre approved by HNZPT. Building used and maintained with Play centre funding.
Original Site Recommendation	HNZPT Ref: 4238. Heritage Advisor, HNZPT.
Current Use	Waotu-Puketurua Play centre

Repair of the Structure - PER. Refer to HH-R1 Protection focus - 1.

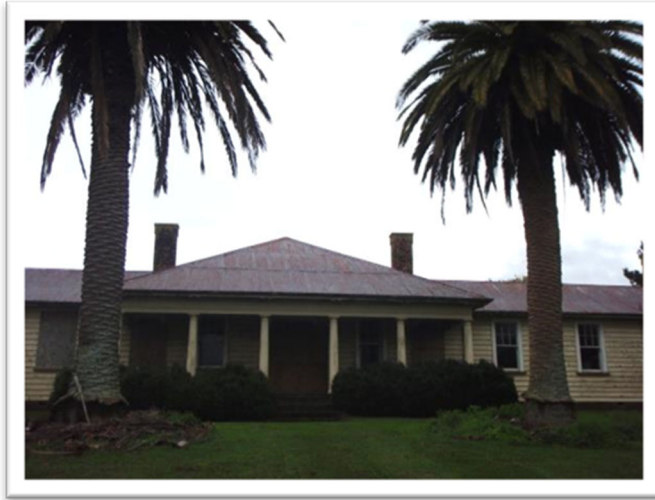
## HH-24: Hodderville Homestead, Boys' Home And Training Farm (Front Part Of Main T-Building Only)

Condition	Currently vacant except Supervisor's house. Supervisor's house used as a residence. Front of properties being maintained.
Original Site Recommendation	Public consultation, confirmed by Heritage Advisor, HNZPT.
Current Use	Supervisor's house in use. Other buildings vacant.

Repair of Structure - PER. Refer to HH-R1. Protection focus - 1, 10 and 11.

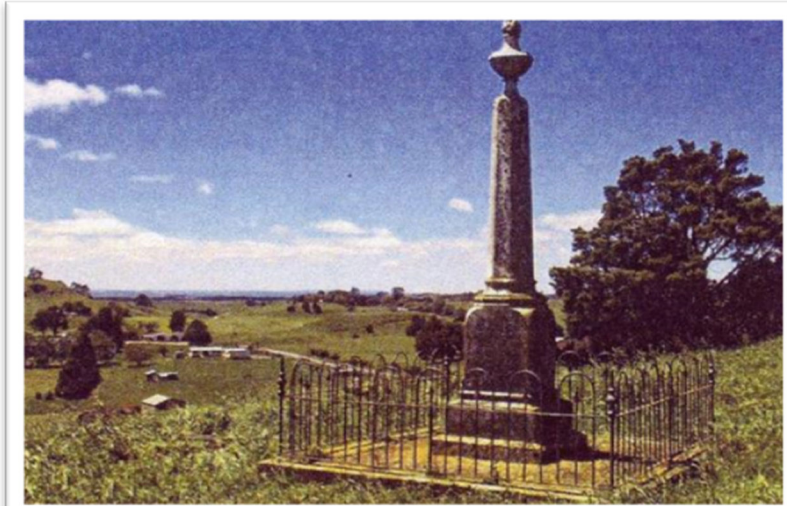
## HH-25: The Marble Monument on Heteri

Date of Construction	1903
Materials	Marble monument with an inscription of lead lettering (Te Waotu Arapuni Heritage Trail Brochure).
Architecture/Engineer/Builder	Unknown
Condition	Reasonable condition. Steel fence barrier protecting from stock.
Original Site Recommendation	Public consultation, confirmed by Heritage Advisor, HNZPT.
Current Use	Monument

Repair of structure - PER. Refer to HH-R1. Protection focus - 4 and 11.

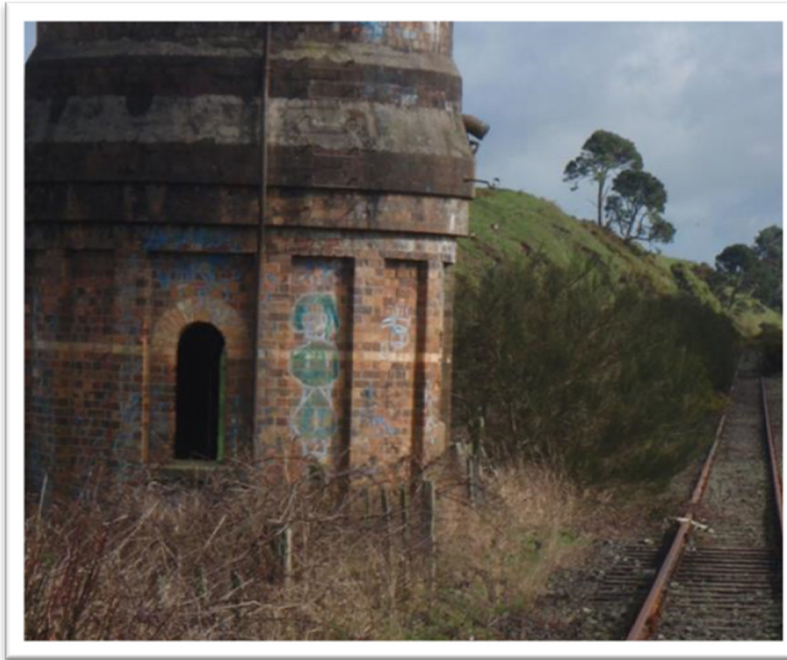
## HH-26: Water Tower - Ngatira

Date of Construction	Probably dates from 1885-86 when two other towers were built
Materials	Brick
Architecture/Engineer/Builder	Engineer: James Stewart CE., Builder: Daniell Fullon (HNZPT).
Condition	Good. The tower is essential infrastructure to the private railway. Tower is of robust construction in comparison to towers associated with public railway. (HNZPT). Significant amount of graffiti on bricks.
Original Site Recommendation	Public consultation confirmed by Heritage Advisor, HNZPT.
Current Use	None - Railway Water tower

Repair of the Structure - PER. Refer to HH-R1. Protection focus - 1, 6, 10, 12 and 13. Building Materials Rule: If repair of the buildings is proposed the materials used for the exterior walls and elements should be similar in type, dimensions and profile as the existing exterior fabric of building. Design rule: Repair or replication work should match the existing design and profile of element.

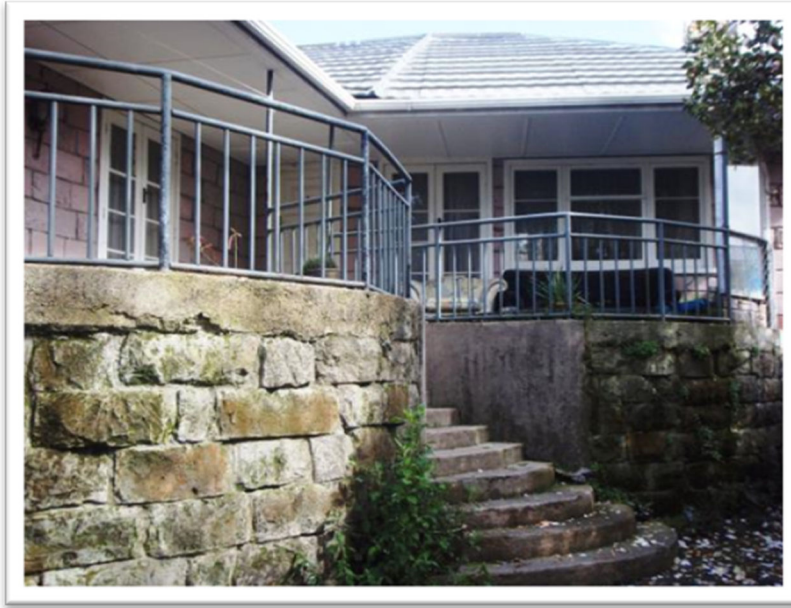
## HH-27: Walsh Rhyolite House

Date of Construction	1940's
Materials	House built from hand cut pink rhyolite rock (only found in the Tokoroa area).
Architecture/Engineer/Builder	Unknown
Condition	Good
Original Site Recommendation	Public consultation and confirmed by Heritage Advisor, HNZPT.
Current Use	Private residence.

Repair of the Structure - PER. Refer to HH-R1. Protection focus - 10 and stone. DIS- stone. Building Materials Rule: If repair of the buildings is proposed the materials used for the exterior walls should be similar in type, dimensions and profile as the existing exterior fabric of the building. Design Rule: Repair or replication work should match the existing design and profile of element.

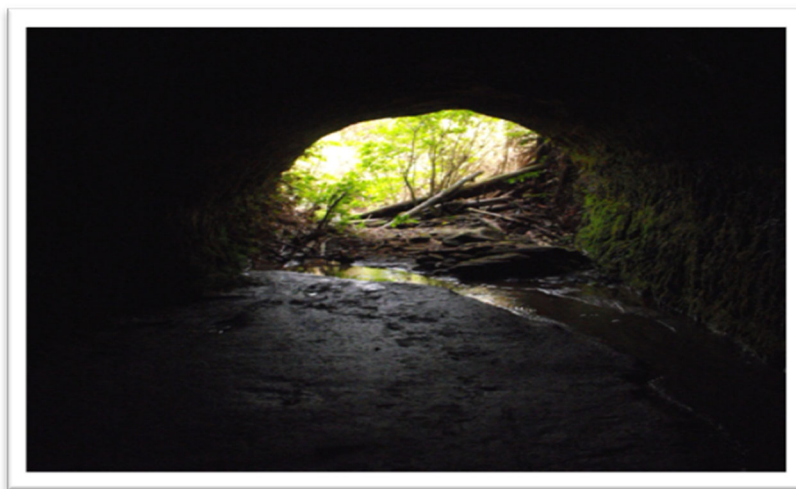
## HH-28A: Lower Crimp Tram Tunnel

Date of Construction	1913
Materials	Tram Tunnel excavated into solid rhyolite hillside. No structural supports or other building materials used.
Architecture/Engineer/Builder	Reportedly built by Huntly Coal Miners, but this is doubtful. It is more likely to have been constructed by the Taupo Totara Timber Company.
Condition	Most of the tunnel itself appears to be in reasonable condition, there is evidence of partial erosion of the roof in places and it is reported that the roof has partially collapsed at one end. It also appears that a narrow water course is emanating out of the southern end of the tunnel.
Original Site Recommendation	NZ Archaeological Assn – Site T16/36 - 52129
Current Use	None - disused Tram Tunnel

Repair /Restoration of the Structure – PER. Refer to HH-R1. Protection focus – 6, 7, 9, 11, and 13. Building Materials Rule: If repair or restoration of the tunnel is proposed, where possible the materials used should be similar in type, dimensions and profile as the original. Design Rule: repair or replication work should match the existing design and profile of element. Restoration of missing parts allowed where there is a high level of authenticity.

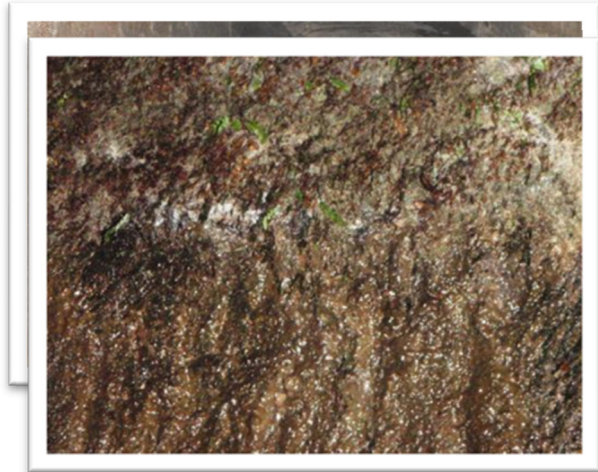
Areas of erosion on ceiling of tunnel clearly visible.

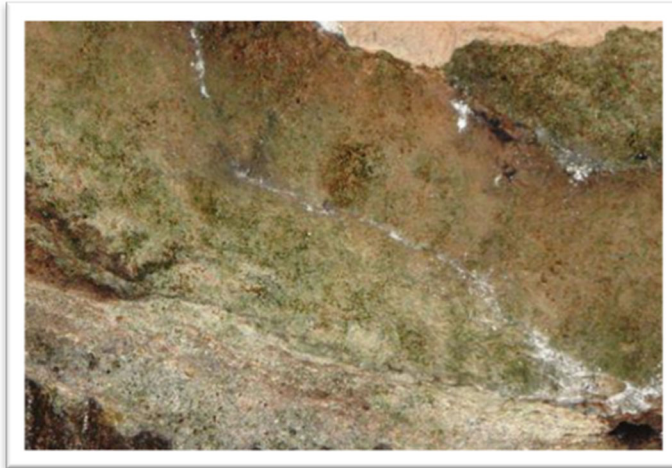
Tunnel floor with evidence of railway sleeper positions still visible. Water course also apparent.

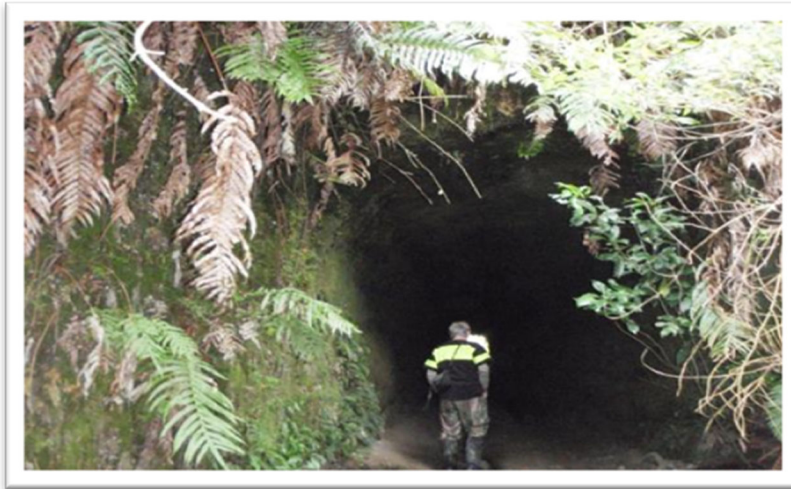
## HH-28B: Tunnel Road – Western Tram Tunnel

Date of Construction	Circa 1900
Materials	Tunnel excavated into solid rhyolite hillside. No structural supports or other building material used
Architecture/Engineer/Builder	Believed to have been constructed by the Taupo Totara Timber Company.
Condition	The tunnel itself is in good condition, although the sides are scraped due to vehicles carrying large loads. Also interior walls have recently been subjected to graffiti and scarring by vandals.
Original Site Recommendation	NZ Archaeological Assn – Site T15/192 - 52062
Current Use	None - disused Tram Tunnel.

Repair /Restoration of the Structure – PER. Refer to HH-R1. Protection focus – 6, 7, 9, 11, and 13. Building Materials Rule: If repair or restoration of the tunnel is proposed, where possible the materials used should be similar in type, dimensions and profile as the original Design Rule: repair or replication work should match the existing design and profile of element. Restoration of missing parts allowed where there is a high level of authenticity.

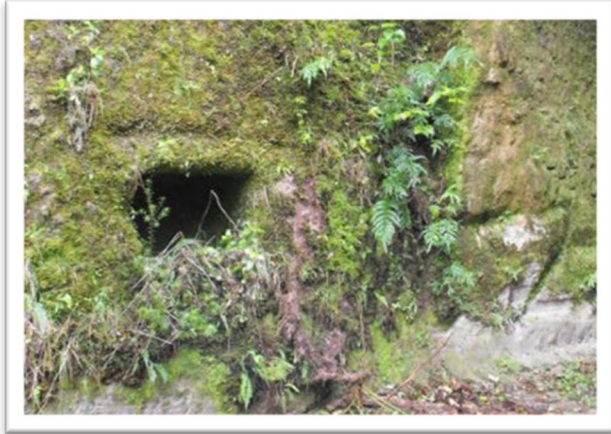
Excavated hole for placing oil lamp, just outside tunnel entrance

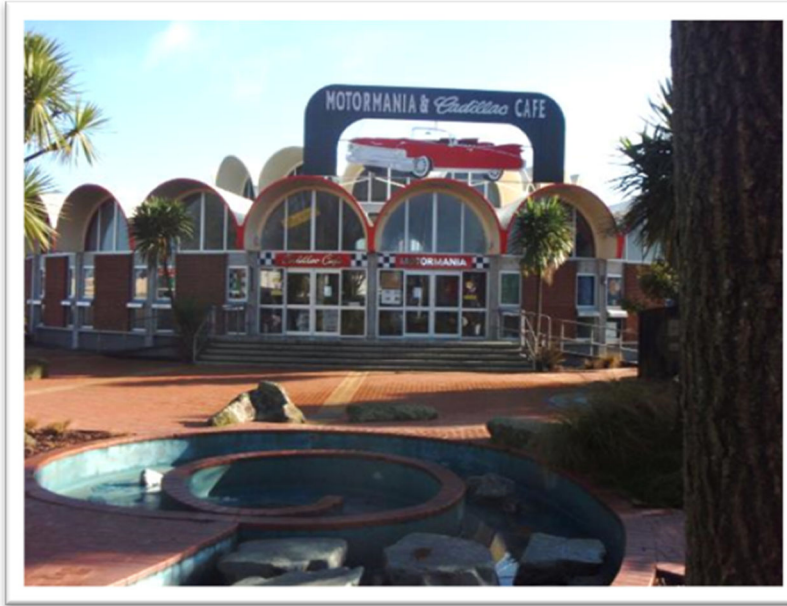
## HH-32: Putāruru Post Office

windows set in aluminium/steel? frames. Roof Verges: Semi-circular concrete arches. Doors: Sliding and casement with one over one glass
Architecture/Engineer/Builder	FGF Sheppard, Government Architect.
Condition	Excellent. Some internal changes to suit use as a museum. Main foyer intact.
Original Site Recommendation	Public consultation confirmed by Heritage Advisor, NZHPT.
Current Use	Food Court and Café

Repair of the Structure - PER. Refer to HH-R1 Protection focus - 9, 10, 12 and 13. Building Materials Rule: If repair of the building is proposed the materials used for the exterior walls and elements should be similar in type, dimensions and profile as the existing exterior fabric of the building, i.e. brick, metal framed windows etc. Design Rule: Repair or replication work should match the existing design and profile of element.

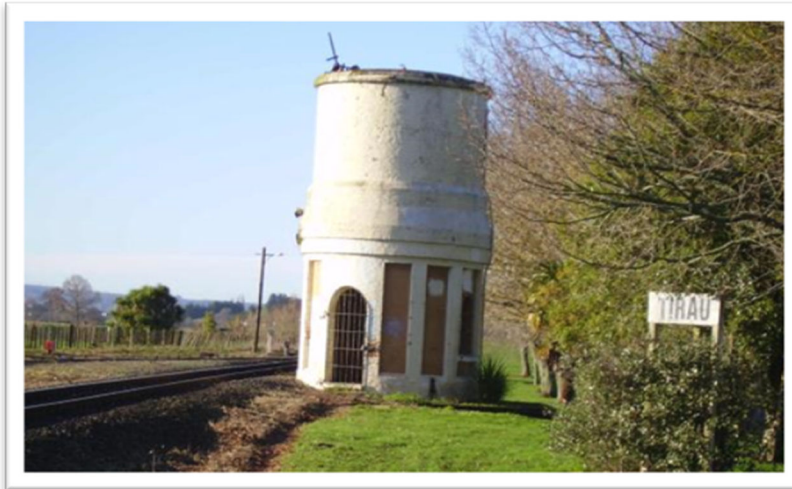
## HH-33: Water Tower - Prospect Avenue

Date of Construction	1885 - 1886
Materials	Two storey. Cylinder. Brick.
Architecture/Engineer/Builder	Architect: Unknown; Engineer: James Stewart; Builder: Daniell Fullon.
Condition	Good. The tower is essential infrastructure to the private railway. Tower is of robust construction in comparison to towers associated with public railway. (HNZPT)
Original Site Recommendation	HNZPT Ref: 4230. Heritage Advisor HNZPT.
Current Use	Railway Water tower - disused (HNZPT)

Repair of the Structure - PER. Refer to HH-R1. Protection focus - 1, 6, 10, 12 and 13. Building Materials Rule: If repair of the buildings is proposed the materials used for the exterior walls and elements should be similar in type, dimensions and profile as the existing exterior fabric of building. Design rule: Repair or replication work should match the existing design and profile of element.

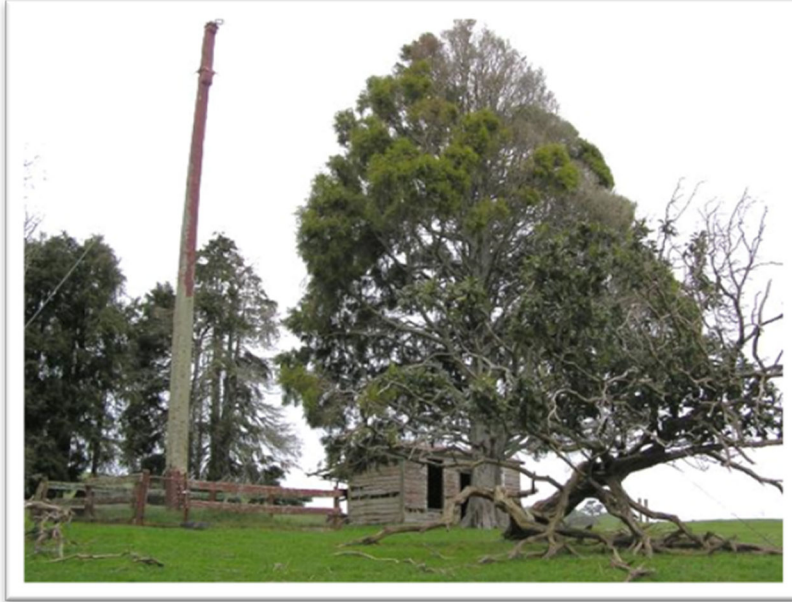
## HH-34: Motai Niu Pole (T15/193)

Date of Construction	1865 (according to local tradition but no exact date could be established)
Materials	Totara
Architecture/Engineer/Builder	
Condition	Good. The wire stays have were replaced or tightened recently. The niu pole was conserved in the 1980s. At that time an archaeological investigation was carried out at the site to gather additional information about the pole. (The report has been added to this record as additional information). The pole was 14 metres high when assessed for conservation in the early 1980s. 2.50 metres were below ground and deteriorated. 1.25m of the pole which was in the ground broke off when it was being removed for treatment. The base dimensions of the pole are 43 x 38 cm. An iron hook is located

<p>around the top of the pole. It is believed the hook held a cross timber or spar in place near the top of the pole. The base of the pole is fenced. Local history suggests there was a garden in this zone at the base of the pole. (A paper is attached that describes the pole and the treatments used to stabilise the pole).</p> <p>A small derelict house is located near the pole. The back of the house has collapsed and is open to the weather, but the main structure is still stable.</p>
Original Site Recommendation	<p>Cowan, J (1983) The New Zealand Wars Vol 1. NZAA Site Record T15/193.</p> <p>Martelletti, N (1996) Kuranui Historic Pole NZ Historic Places Trust Magazine.</p> <p>Peters, K (1990) Conservation of a Niu Pole at Kuranui and Excavation Report 1980.</p> <p>Stokes, E (1980) Pai Marire The Niu at Kuranui (Occasional paper no 6)</p>
Current Use

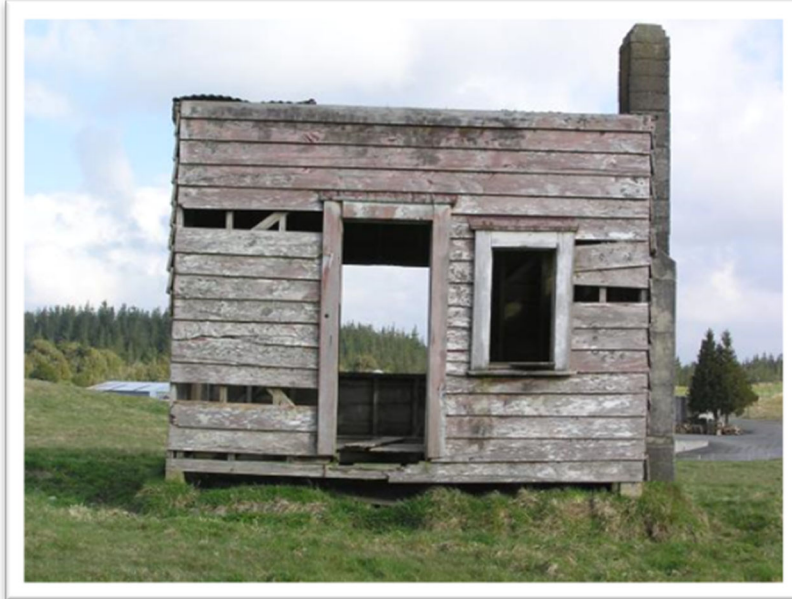
## HH-35: Stockmans Hut

Date of Construction	1935 - 1940; fire place circa early 1950s
Materials	Wooden weather boards; single skin of exterior weather boards on a timber frame. Concrete piles and pre-cast concrete block fireplace. Round nails, rose-head and flat top used to attach boards, repair (re-nailing) is evident. The frame is lashed to the concrete piles with #8 wire (see additional photos). The wire feeds through holes in the piles. The roof is corrugated iron. No metal door or window hardware was evident
Architecture/Engineer/Builder	TS Duncan or more probably Albert Hemmings
Condition	Stable Condition and high level of integrity. Many of the floor boards, some of the weatherboards, the windows, and door are missing. No major areas of wet rot were evident. The
